THICKNESS REQUIREMENTS FOR SOILS BENEATH  
LANDING MATS; BARE BASE SUPPORT

MISCELLANEOUS PAPER S-71-3

# THICKNESS REQUIREMENTS FOR SOILS BENEATH LANDING MATS

BARE BASE SUPPORT

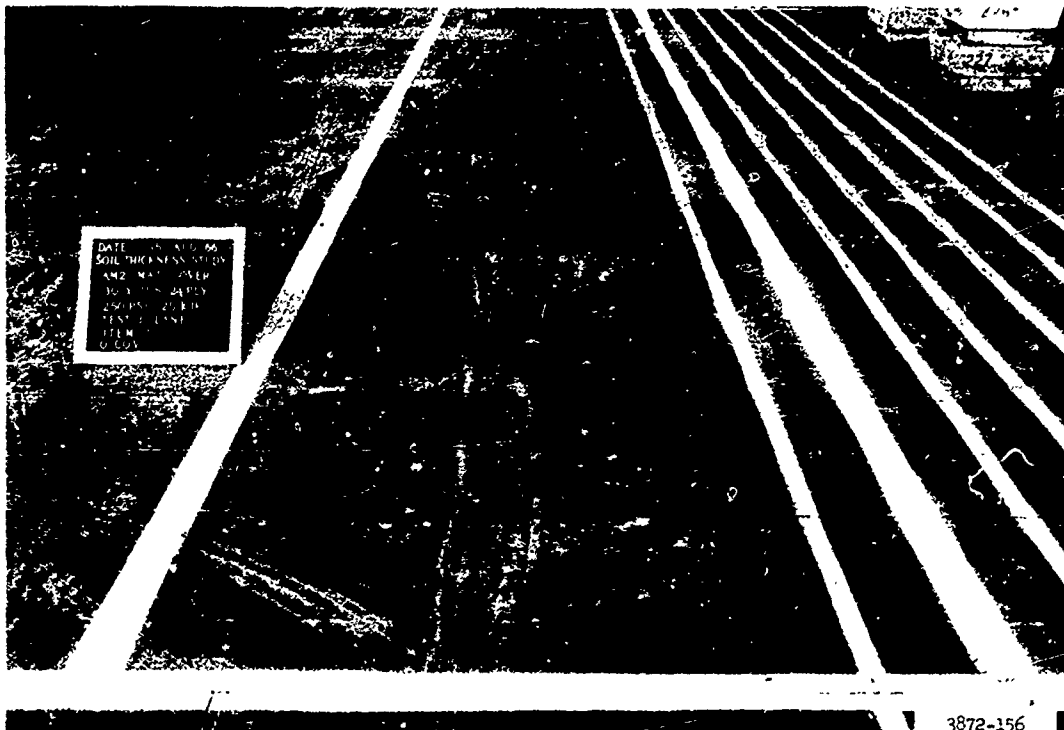
Photograph A75. Test section V prior to traffic
